NACA RM E51K06

INVESTIGATION OF TURBINE-OUTLET TEMPERATURE DISTRIBUTION OF XJ34-WE-32 TURBOJET ENGINE

By W. R. Prince and J. T. Wintler

Lewis Flight Propulsion Laboratory
Cleveland, Ohio

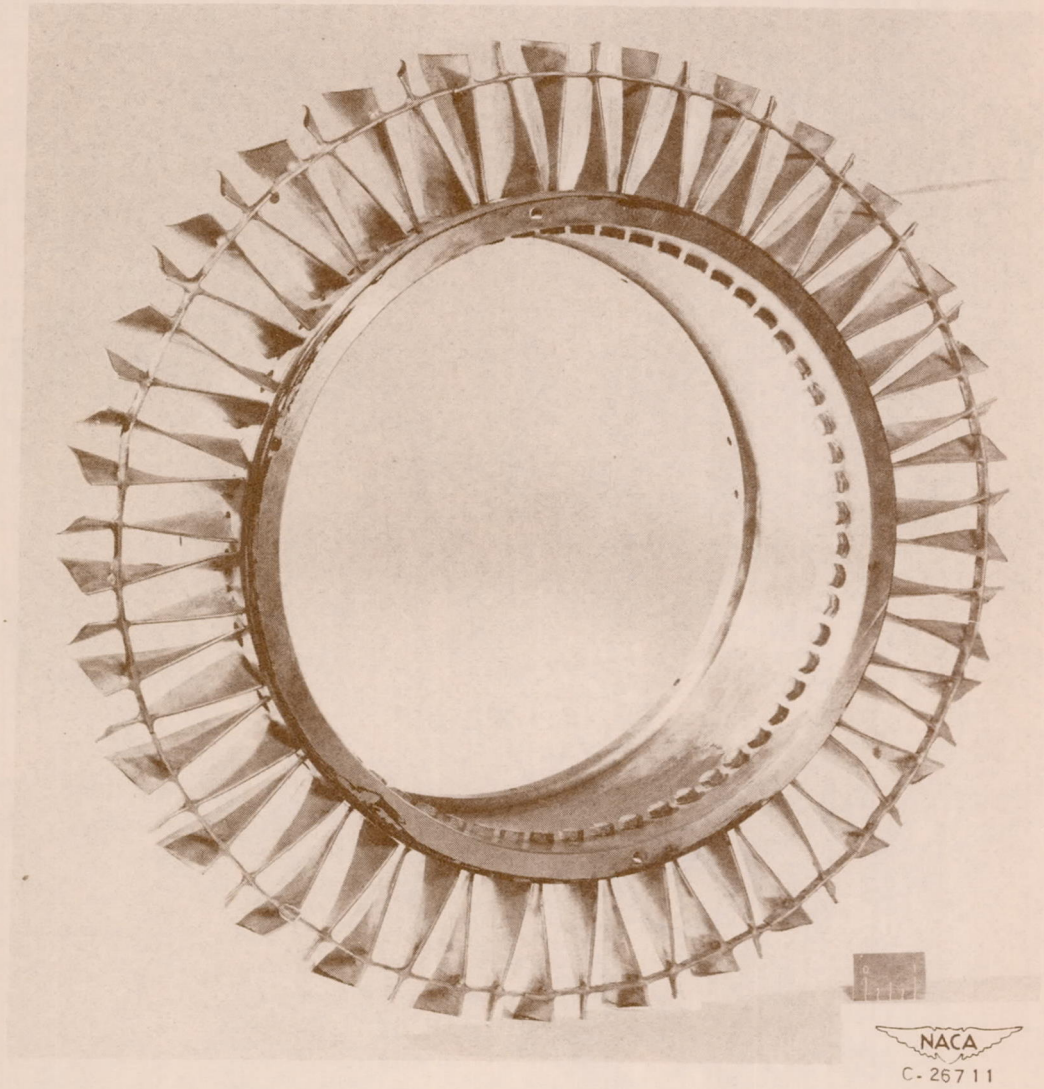
Figure 4. - Compressor-outlet mixer vane assembly.

The mixer assembly (fig. 4) consisting of 60 stationary vanes was installed 5/16-inch downstream of the trailing edge of the second stage straightening vanes at the compressor outlet. Each vane had a chord of $1\frac{1}{2}$ inch and an approximate span of 3 inches and was constructed by fixing the midspan section parallel to the axis of the engine; the root and tip sections of adjacent vanes were twisted about 30° in opposite directions. The action of the mixer vanes on the compressor-outlet air flow was such that in alternate vanes the air at the tips was forced downward in the direction of increased area and the air at the roots followed an upward path also in the direction of increased area thus resulting in turbulent mixing of the air entering the combustor.

In order to improve the compressor-outlet radial velocity profiles, the engine manufacturer designed and fabricated a stage of stationary mixer vanes that was installed directly downstream of the last stage of straightening vanes at the compressor outlet. The effect of these mixer vanes on

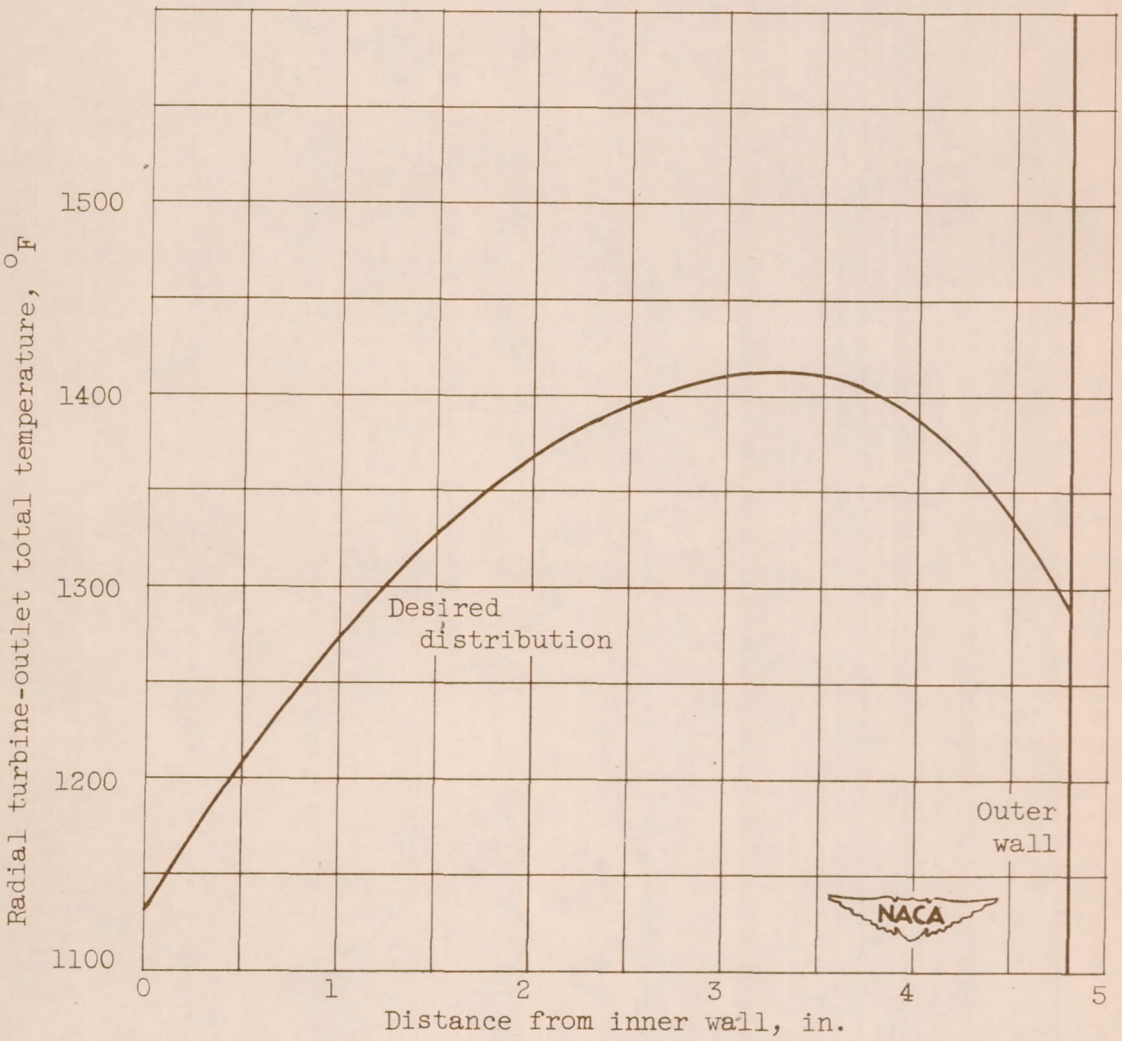
Figure 5. - Limitation of radial turbine-outlet total temperature $4\frac{5}{8}$ inches downstream of turbine flange in XJ34-WE-32 engine.

The manufacturer's desired radial turbine-outlet temperature distribution at the measuring station $4\frac{5}{8}$ inches downstream of the turbine flange is plotted in figure 5 as a function of passage height. The temperature varies spanwise from a value of 1130° F at the blade root to a peak value of 1415° F at a point on the blade $2\frac{3}{4}$ inches from the root ($3\frac{1}{4}$ in. from the inner wall at the measuring station) and then decreases to 1290° F at the blade tip. This temperature distribution was established by the manufacturer as the optimum curve from blade stress and maximum turbine-output conditions determined from investigation of both the turbine blades and stationary nozzles at simulated loads and temperatures corresponding to actual turbine operating conditions.

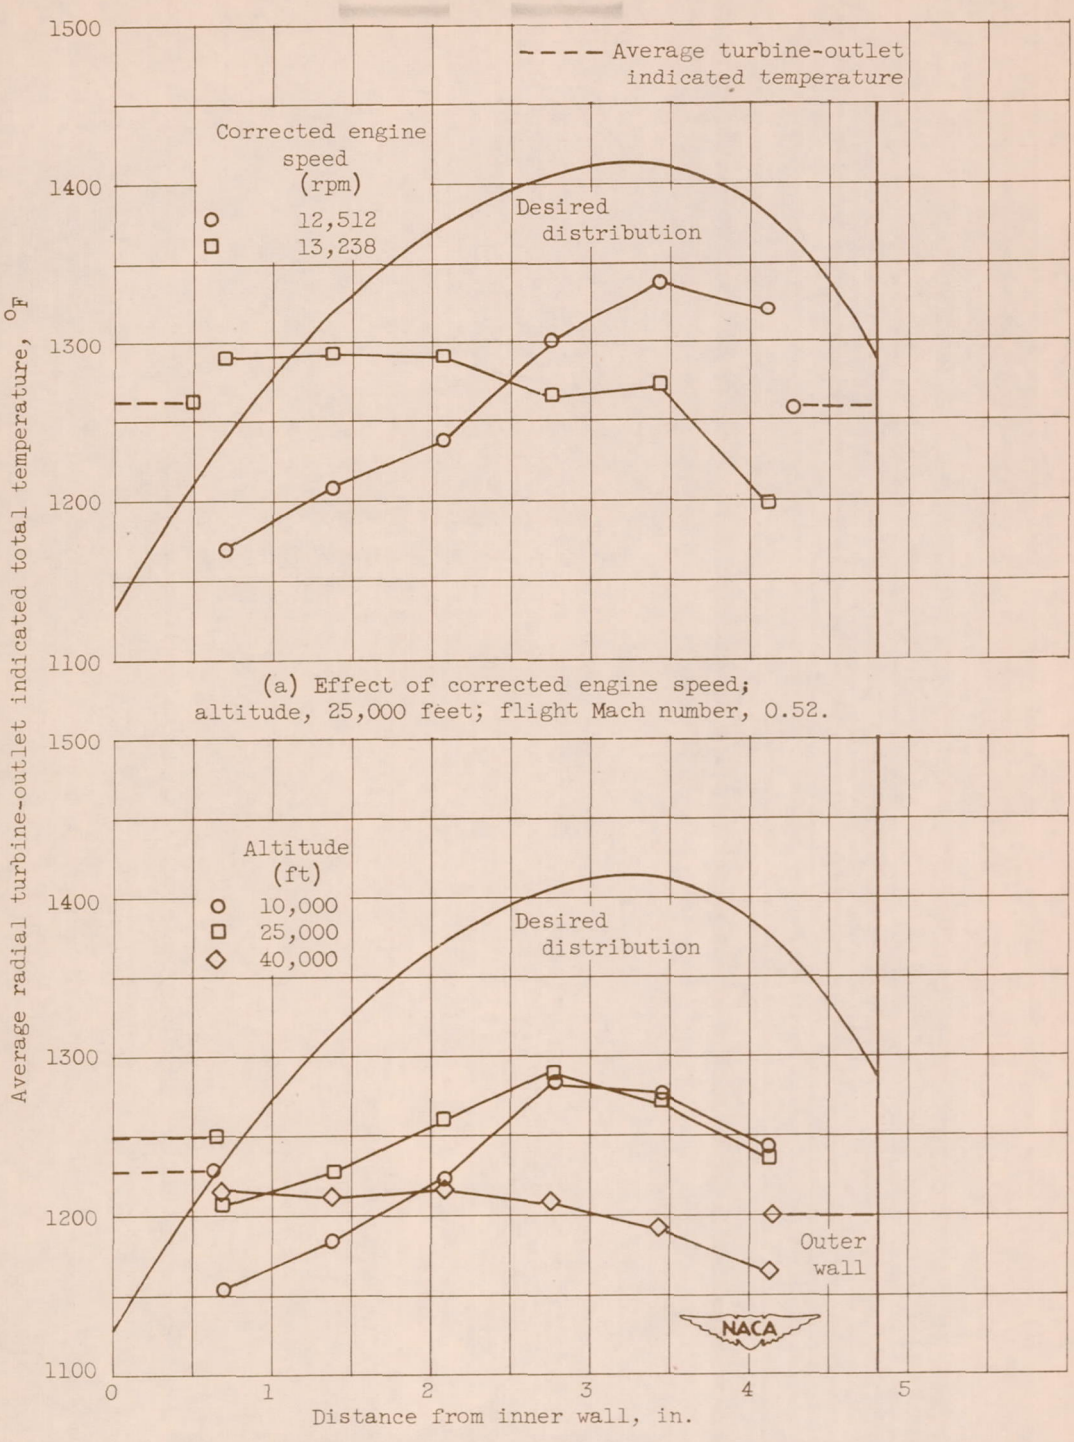
Figure 6. - Effect of corrected engine speed and altitude on radial turbine-outlet temperature distribution in XJ34-WE-32 engine without mixer vanes.

Effect of corrected engine speed and altitude. - The effect of corrected engine speed and altitude on the average radial turbine-outlet temperature distribution for the engine without the mixer assembly is shown in figure 6. The radial temperature distribution (fig. 6(a)) at an altitude of 25,000 feet and rated engine speed (corrected engine speed of 12,512 rpm) is considered satisfactory from the standpoint of the manufacturer's desired limit. For the same flight conditions, increasing the corrected engine speed to 13,238 rpm resulted in an inversion of the temperature pattern; that is, the temperature near the turbine root was considerably higher than the temperature at the tip. The increase in temperature at the root section exceeded the manufacturer's average limit and further increase in the average gas temperature at the turbine outlet would result in severe local overtemperaturing. As a result of this temperature inversion at high corrected engine speeds, it was necessary to operate the engine at lower average turbine-outlet temperatures to conserve turbine life. The reduction in average temperature was accompanied by reduced thrust output of the engine. A similar inversion of turbine-outlet temperature also occurred (fig. 6(b)) with increase in altitude to 40,000 feet at a constant corrected engine speed of 12,427 rpm.

(a) Effect of corrected engine speed; altitude, 25,000 feet; flight Mach number, 0.52.

(b) Effect of altitude; average corrected engine speed, 12,427 rpm; flight Mach number, 0.52.

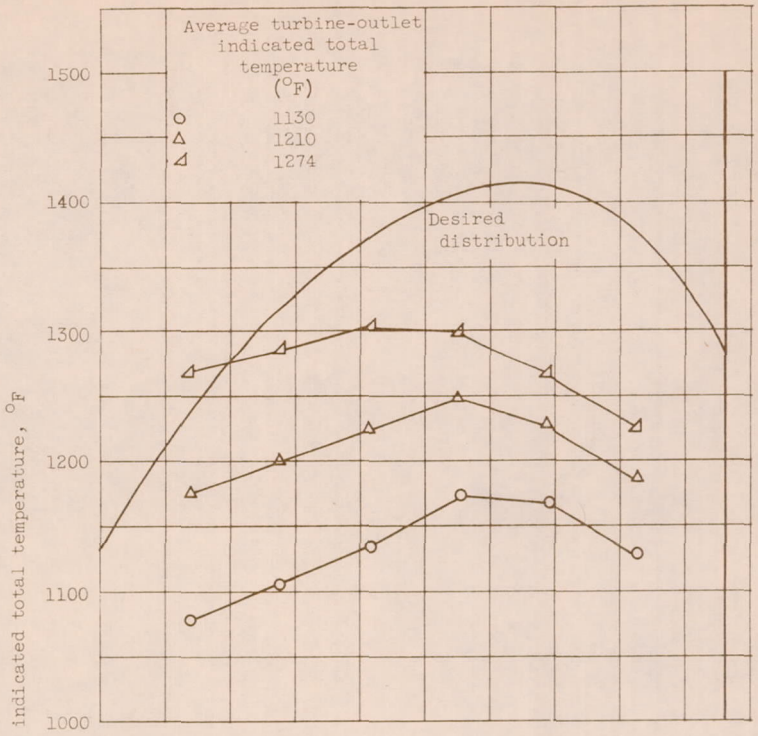
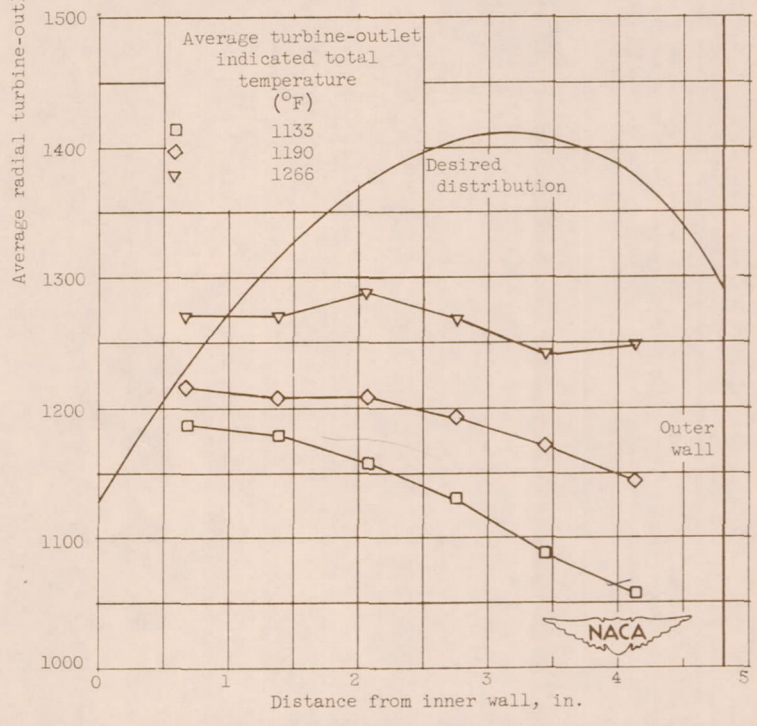
Figure 7. - Effect of temperature level on radial turbine-outlet temperature distribution in XJ34-WE-32 engine without mixer vanes. Average corrected engine speed, 13,283 rpm.

Effect of temperature level. - The effect of variations in turbine-outlet temperature level for the engine without the mixer assembly on the radial turbine-outlet temperature distribution at altitudes of 5000 and 40,000 feet and an average corrected engine speed of 13,283 rpm is shown in figure 7. At low altitude (fig. 7(a)), the temperature distribution was satisfactory for the low temperature levels; however, at high turbine-outlet temperature (1274° F), the distribution was undesirable. For an altitude of 40,000 feet (fig. 7(b)), undesirable temperature distributions existed at all temperature levels with a trend toward a less desirable distribution with decrease in temperature level.

(a) Altitude, 5000 feet; flight Mach number, 0.26.

(b) Altitude, 40,000 feet; flight Mach number, 0.52.

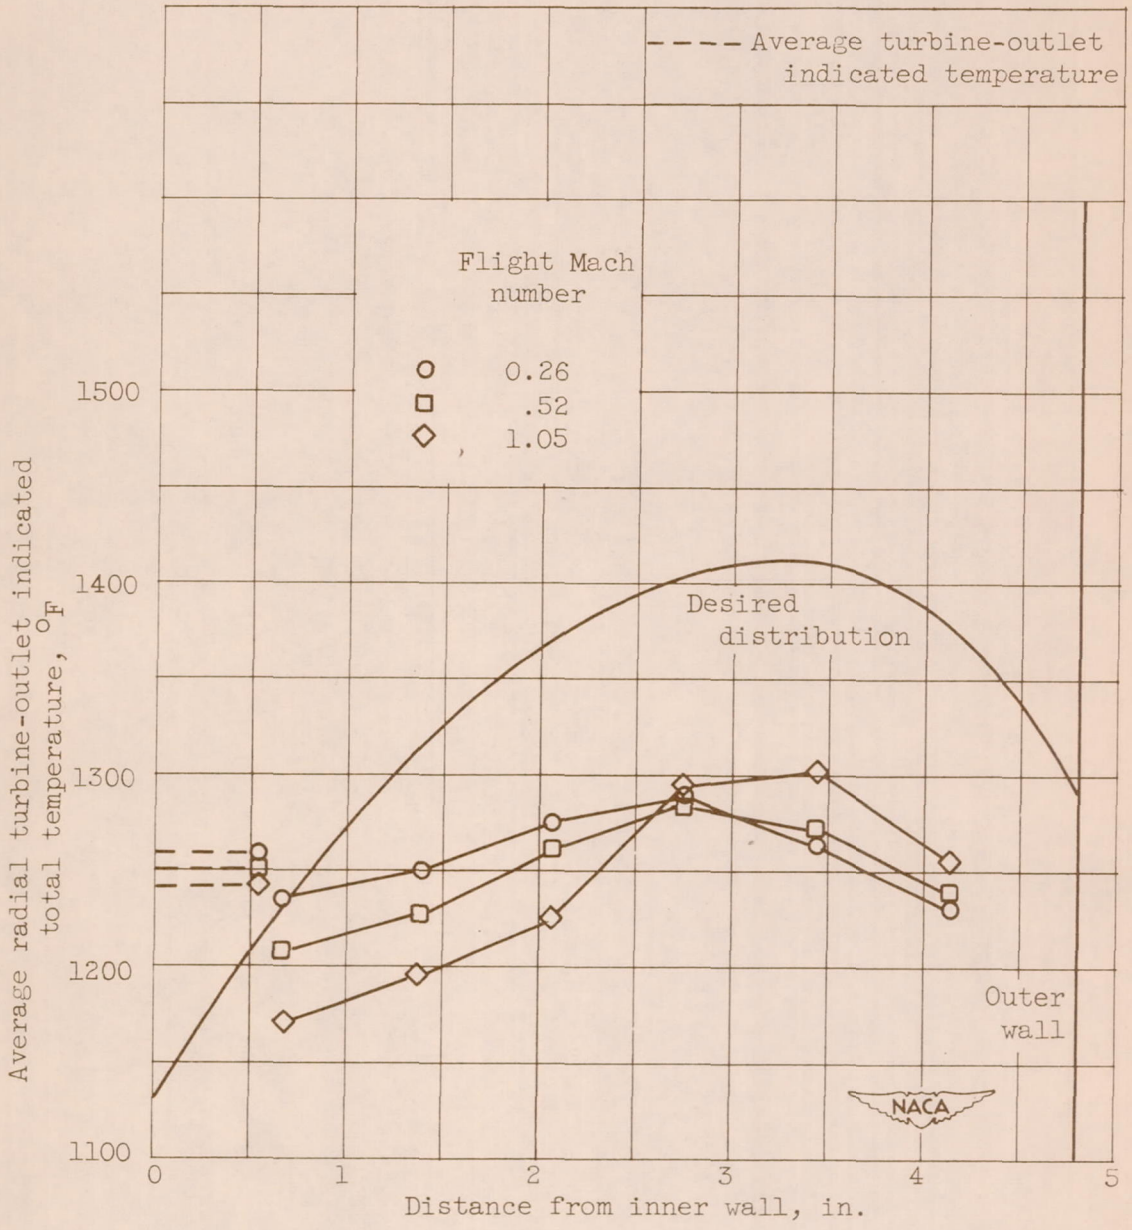
Figure 8. - Effect of flight Mach number on radial turbine-outlet temperature distribution in XJ34-WE-32 engine without mixer vanes. Altitude, 25,000 feet; corrected engine speed, 12,415 rpm.

Effect of flight Mach number. - The effect of flight Mach number on radial turbine-outlet temperature distributions (without mixer) at an altitude of 25,000 feet and corrected engine speed of 12,415 rpm is shown in figure 8. Variations in flight Mach number did not appreciably affect the temperature distribution, however, an increase in flight Mach number slightly improved the temperature distribution with respect to the desired limit.

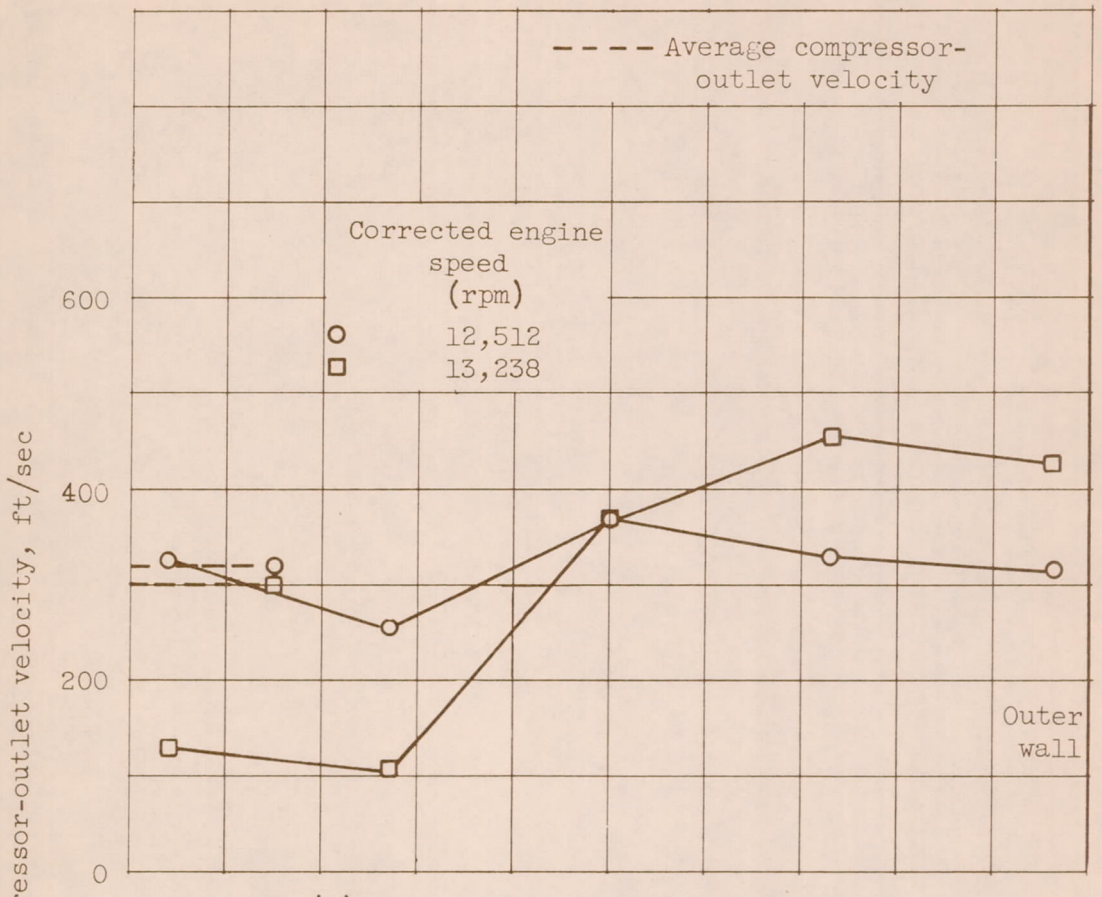
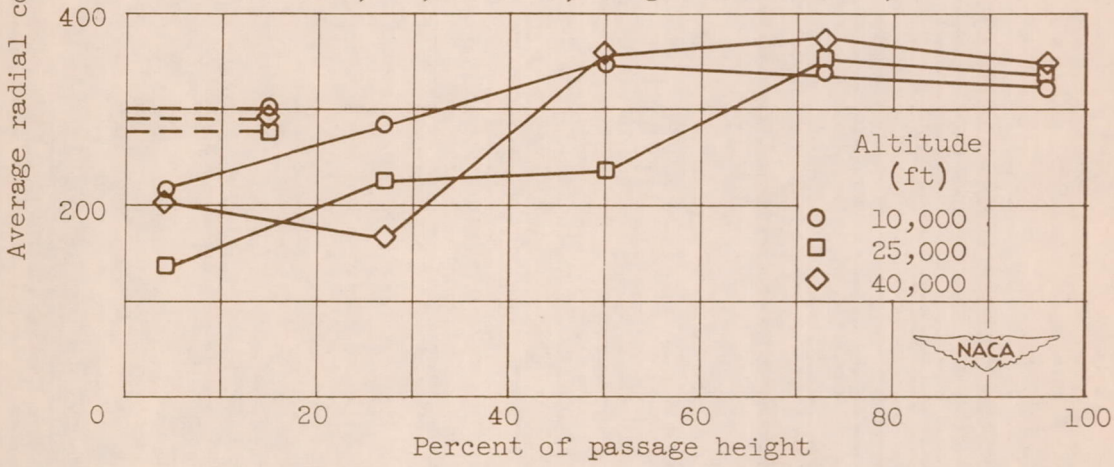
Figure 9. - Effect of corrected engine speed and altitude on radial compressor-outlet velocity distribution in XJ34-WE-32 engine without mixer vanes.

The adverse radial temperature distribution shown to exist for the engine without the mixer at the turbine outlet during conditions of either high corrected engine speed or high altitude is partially explained by the effect of the two aforementioned conditions on the average radial compressor-outlet velocity distribution (fig. 9). At a condition for which the temperature distribution at the turbine outlet was satisfactory (corrected engine speed, 12,512 rpm; altitude, 25,000 ft) the radial compressor-outlet velocity distribution (fig. 9(a)) was fairly uniform across the flow passage with velocities of approximately 300 feet per second at the root and tip sections and a peak velocity occurring at the midspan of about 350 feet per second. An increase in corrected engine speed at the same flight conditions, which resulted in an adverse turbine-outlet temperature distribution, was associated with an increase in the peak velocity to 450 feet per second at the tip section and a decrease in velocity at the root section to approximately 100 feet per second. The lower velocity at the root section and consequently the lower air flow in the inner portion of the compressor-outlet annulus resulted in a fuel rich region in the inner annulus of the combustion basket and an increase in turbine root temperature. The change in velocity profile at the compressor outlet is attributed to a change in compressor characteristics with change in compressor-inlet Mach number (corrected engine speed). Another possible factor contributing to the adverse temperature distribution is insufficient turbulence in the combustion chamber to thoroughly mix the gas before it enters the turbine. The temperature shift due to an increase in altitude is, however, not accompanied by any definite shift in the compressor-outlet velocity distribution (fig. 9(b)); therefore, the temperature inversion that occurs at high altitude is presumed to primarily originate in the engine combustor.

(a) Effect of corrected engine speed; altitude, 25,000 feet; flight Mach number, 0.52.

(b) Effect of altitude; average corrected engine speed, 12,427 rpm; flight Mach number, 0.52.

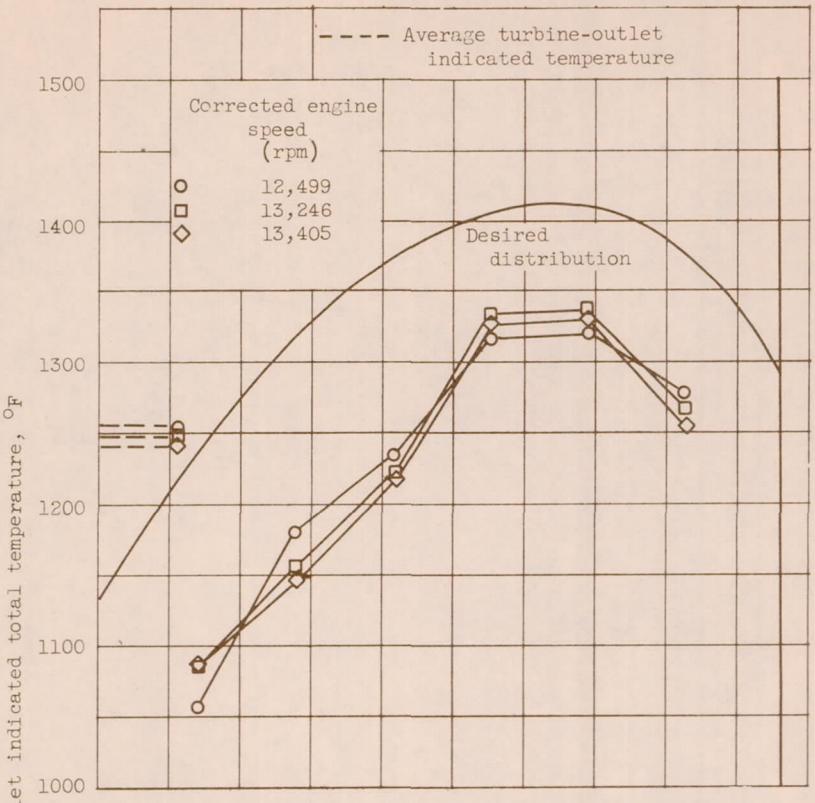
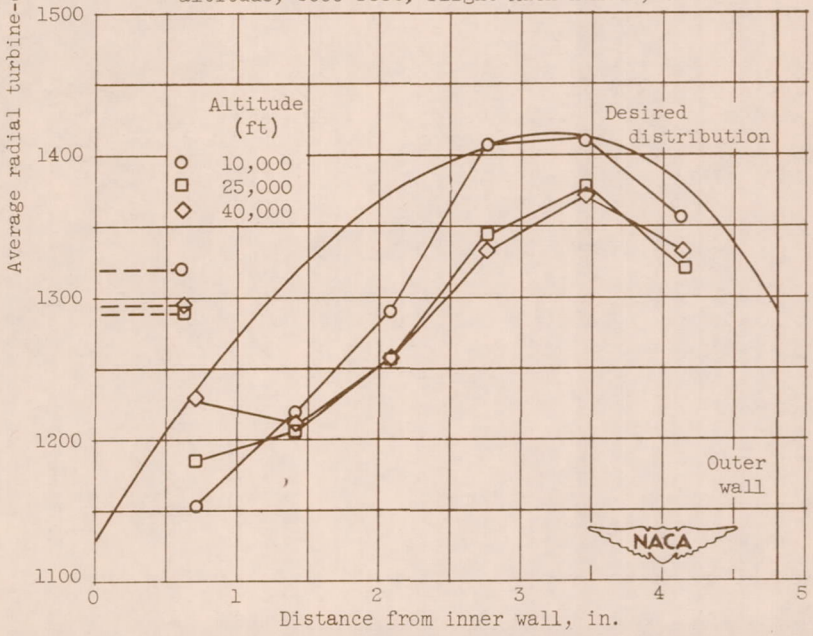
Figure 10. - Effect of corrected engine speed and altitude on radial turbine-outlet temperature distribution in XJ34-WE-32 engine with mixer vanes.

radial turbine-outlet temperature distribution for a range of corrected engine speeds, altitudes, temperature levels, and flight Mach numbers is presented in figures 10 to 12, respectively. In general, it is shown that the turbine-outlet temperature profile shift associated with both increase in corrected engine speed and altitude was no longer evident with the compressor-outlet mixer vanes installed. As a result of the turbine temperature distribution being unaffected by changes in engine or flight conditions with the mixer installed, the engine can be operated at rated turbine-outlet temperature without sacrificing turbine life.

(a) Effect of corrected engine speed; altitude, 5000 feet; flight Mach number, 0.26.

(b) Effect of altitude; average corrected engine speed, 13,208 rpm; flight Mach number, 0.52.

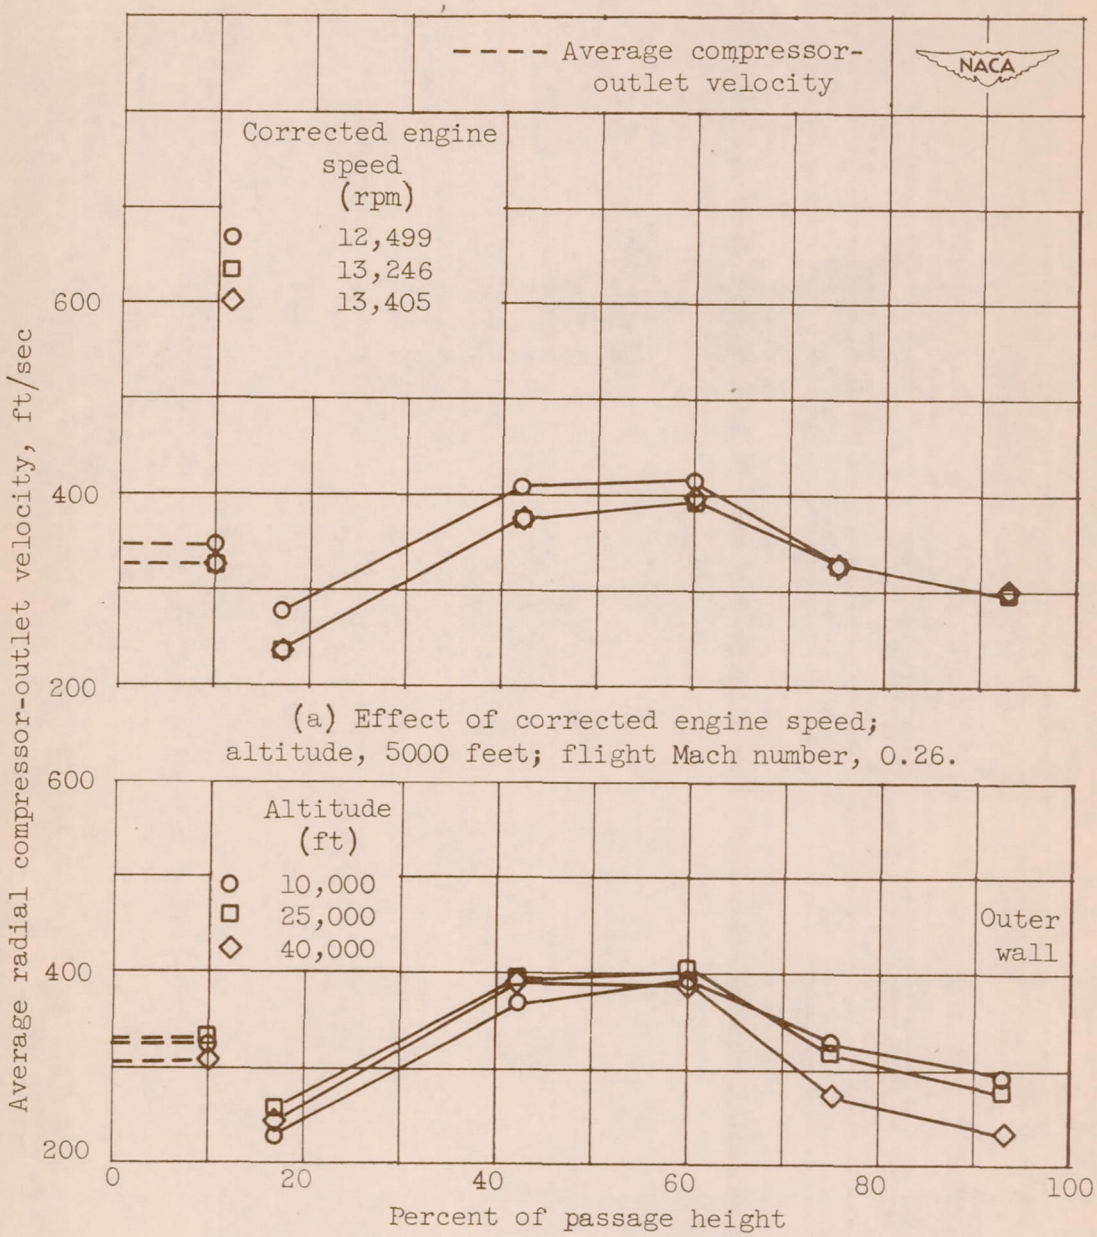
Figure 13. - Effect of corrected engine speed and altitude on radial compressor-outlet velocity distribution in XJ34-WE-32 engine with mixer vanes.

The satisfactory turbine-outlet temperature distributions for the engine with the mixer installed are attributed to the action of the mixer on the compressor-outlet velocity distribution coupled with introduction of turbulence into the air stream entering the engine combustor. The average radial compressor-outlet velocity distributions with mixer (fig. 13) were approximately symmetrical about the center of the annulus and were not appreciably affected by changes in corrected engine speed or altitude.

(a) Effect of corrected engine speed; altitude, 5000 feet; flight Mach number, 0.26.

(b) Effect of altitude; average corrected engine speed, 13,208 rpm; flight Mach number, 0.52.
